U. S. NAVAL *Aviation Safety* REVIEW

NAVAER 00-75-510

JULY 1955

Maintenance—key to safer flight

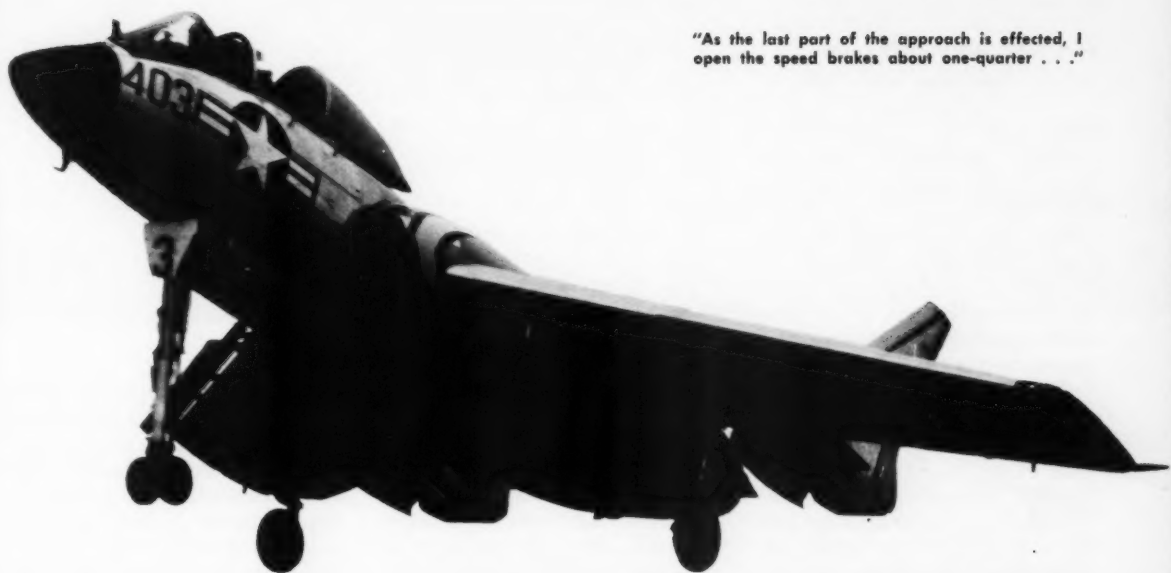
"As the last part of the approach is effected, I open the speed brakes about one-quarter . . ."

hold a sink speed of 5-8 feet-per-second. (300 to 500 fpm). In the last part of the approach I open the speed brakes about one-quarter, which requires more thrust to hold a comfortable rate-of-sink.

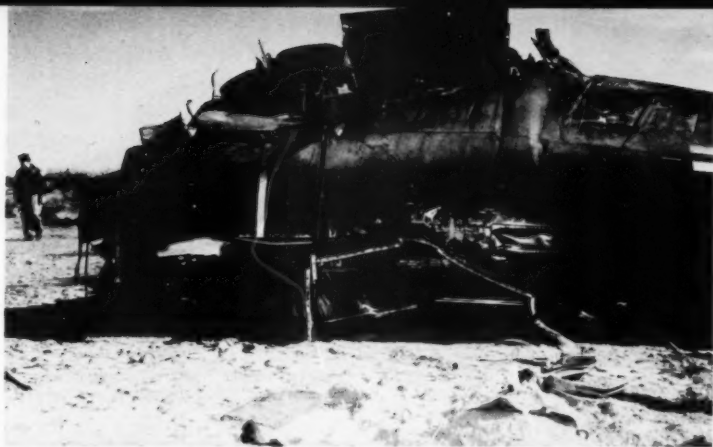
TORQUE ROLL following a message drop.

at 90 knots, full flaps, 2400 rpm, 25 inches manifold pressure. Upon releasing the message he went into an easy left bank and added throttle. As he added throttle the left wing went down with an increasing rate of roll. To offset this the pilot retarded throttle, which

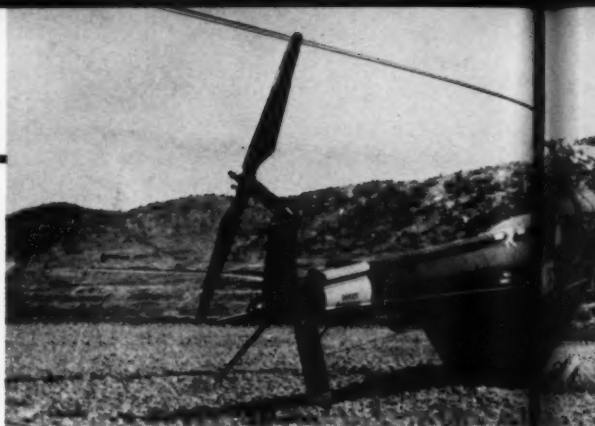
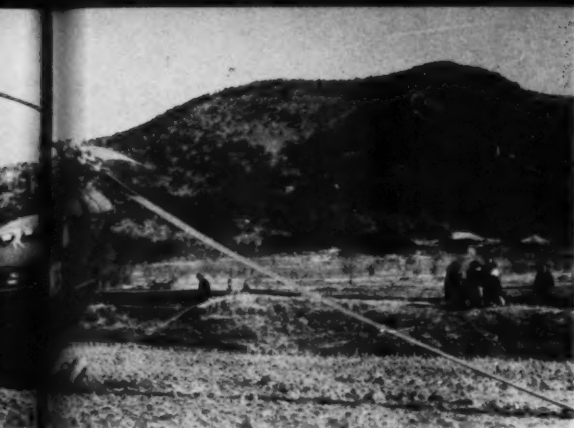
FAULTY FUEL GAGES can be especially serious during maximum

us de maximum load, short haul helicopter operations.

The investigation disclosed that the front tank fuel gage registered 70 pounds of fuel remaining. The actual measurement was one quart or about two pounds. The pilot had selected this tank, believing it to be the fullest. The aft fuel gage registered 40 pounds while the actual measurement was 78 pounds. The 78 pounds of fuel in the aft tank was sufficient for about 20 minutes of flight under normal conditions. The accident occurred only seven minutes from the base at a flight altitude of approximately 500 feet.

It is accepted procedure in transport helicopter operation to operate with reduced fuel loads to increase pay loads for short distances. In view of this fact the AAR Board recommended that maintenance personnel be reminded of the importance of properly calibrating fuel gages. ●

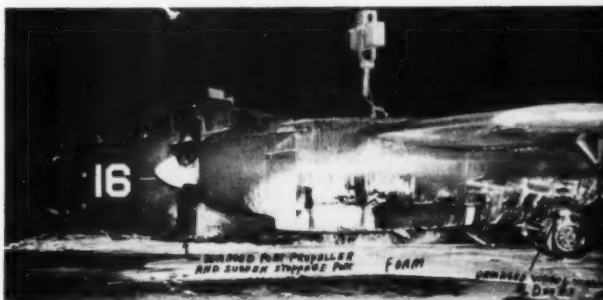
CHAFING SITUATION caused real trouble for an Able Jig crew.

Chafing hydraulic lines resulted in a \$4400 loss in damages, to an AJ-2 which was forced to land wheels-up at night.

Primary cause of the accident was the failure of the landing gear emergency system down line. Cause of the failure was chafing of the down line against the rudder boost line. Secondary cause was the utility system hydraulic failure in the cabin compressor unit due to a faulty Garlock seal losing the hydraulic fluid.

No flight crew errors were involved in this accident; however, reviewing authorities expressed views that maintenance personnel might have detected the lack of clearance during check periods had they inspected for such situations.

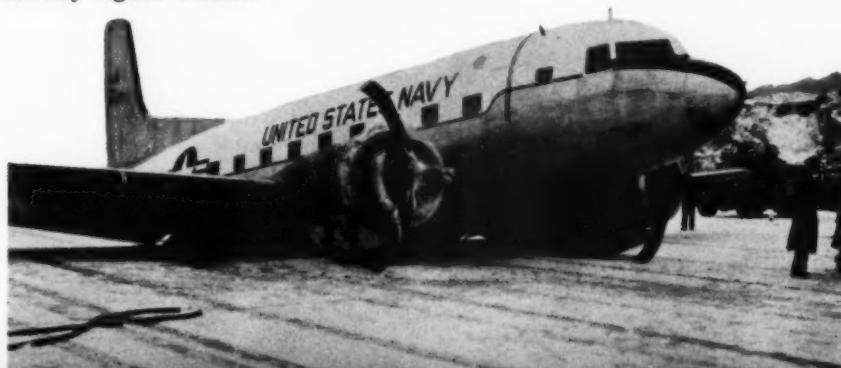
Skillful handling of an in-flight emergency prevented a possible catastrophe.

The R4D-8 received IFR clearance and took off from Kodiak with 21 passengers. Ceiling was 300 ft, indefinite, with three miles visibility varying with rain and snow.

At 200 feet and after entering the overcast, the port engine oversped to 3000 rpm. Returning to the field the pilot asked GCA for an immediate approach. Beginning a left turn in accordance with GCA instructions, troubles multiplied as the starboard engine exploded and began to burn.

Touching down at about 88 knots, the plane slid along the snow-covered runway; passengers and crew abandoned the aircraft. There were no injuries. Crash crews immediately blanketed the starboard engine with foam. As a measure of the excellence of the landing, temporary repairs enabled a flyaway to ConUS for permanent repairs.
